Manhole Inspection Summary

Manhole # S29GG2005MH

Insp Date: 11/21/06 11:39 AM

Location Address: **5708 GREEN LEAF RD**

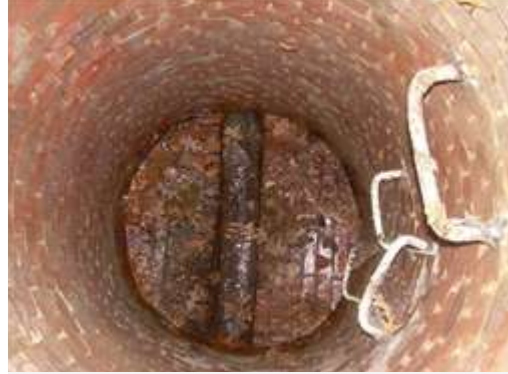
Top View

Evidence of surcharge - Bench debris.
Channel debris.

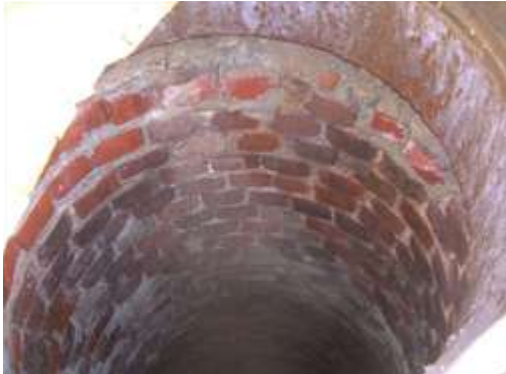
Defect

Frame Offset: **2** (in.) Condition: ☐ Sound ☐ Cracked ☒ **Leaks**

Condition: ☐ Sound ☐ Cracked ☐ Root Intrusion ☐ Loose Brick ☒ **Deteriorated**

Infiltration: ☐ None ☒ **Joint** ☐ Cracks ☒ **Mortar** ☐ Roots ☐ Wall

Infiltration: ☐ None ☐ Joint ☐ Cracks ☒ **Mortar** ☐ Roots ☒ **Wall**

Frame offset. Adjustment deterioration
and infiltration. Corbel infiltration.

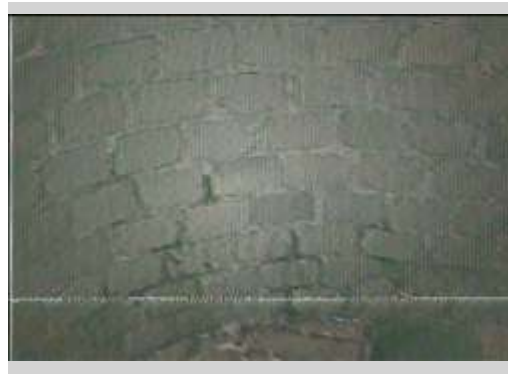
Defect

Infiltration: ☐ None ☐ Joint ☐ Cracks ☒ **Mortar** ☐ Roots ☒ **Wall**

Barrel infiltration.

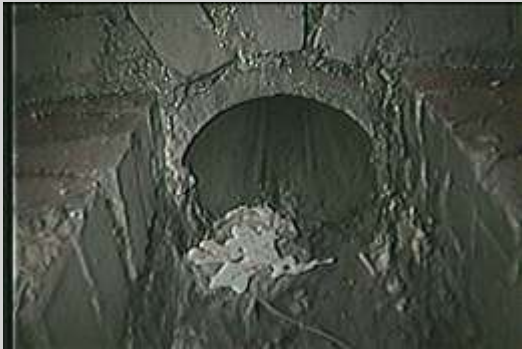
8 in. Circular Gravity Sewer Pipe Out @ 12 O'Clock

Infiltration: **Evidence** Pipe Seal Cond: **Cracked**

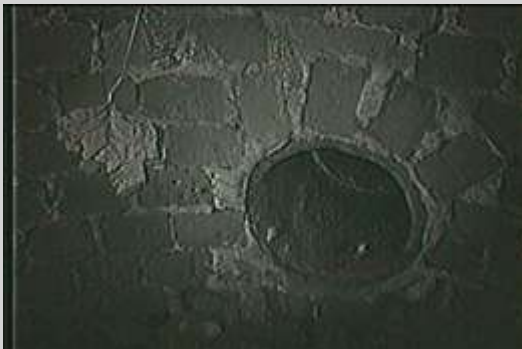
8 in. Circular Gravity Sewer Pipe In @ 6 O'Clock

Infiltration: **Evidence** Pipe Seal Cond: **Unknown**

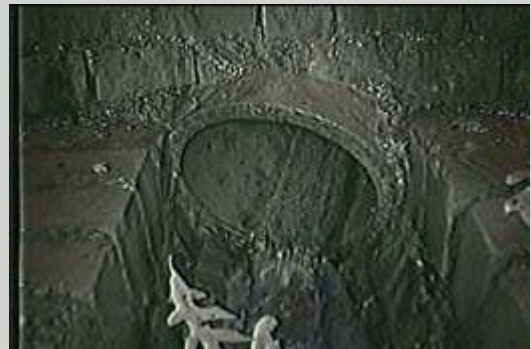
Drop In @ 6 O'Clock

Drop: **Outside** Rod and Bar

Drop Condition: **Open**
